Company: AGL Loy Yang
 Location: Latrobe Valley, Victoria, Australia
 Service Provider: Optical Motion Technologies

Problem

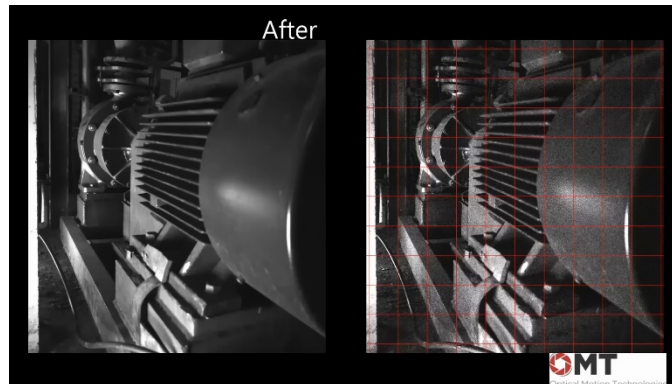
Click on the image above to open a web page to view the video

Optical Motion Technologies (OMT) were contracted to apply RDI's Motion Amplification™ (MA) technology to solving the long running problem on 1-SCP-2. From arriving at the location of the SCPs in the power station, setting up the video camera acquisition system and then collecting nine MA videos took less than one hour. This hour included the time to analyze the results all of which was done in the field. The process involved taking wide angle 'whole of machine' videos, analyzing them in the field and then honing in with zoomed videos on the root cause of the problem. It was clear from the MA videos that the problem was a soft foot condition between the pump base frame and skid base plate. In fact, there was a twisting operational deflection shape of the pump base frame. During a scheduled outage, a series of fillet welds were made across the suction end the pump base frame to the skid base plate. When the pump was returned to duty service the high lateral motion and vibration had been reduced by more than 70% and was now less than 5 mm/sec RMS. The solution to this problem was achieved through the application of RDI's Motion Amplification™ technology for a fraction of the time and cost already incurred.
