# Over US\$48M value realised from Online Vibration Monitoring on a Colliery

Site: Colliery Machine: VSD Drive motor on Incline Conveyor Rating: 750Kw Problem Category: Bearing Defect caused by Electrical Fluting

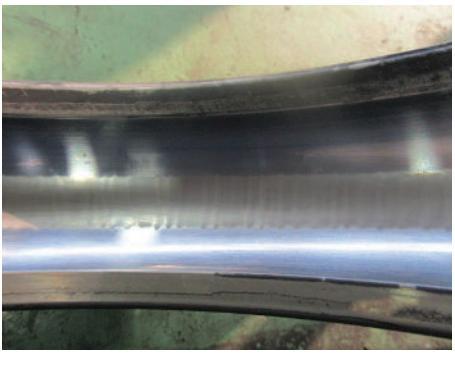
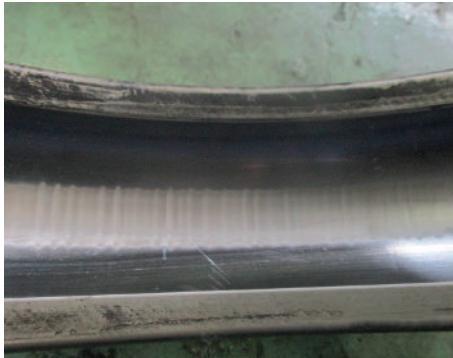
Alarm due to high vibration was observed on the NDE Motor Bearing. Harmonics of Outer Race Defect frequency at 177,6 Hz with side bands spaced at FTF (cage frequency) 10,67 Hz evident in the demodulation and acceleration spectral data comparisons. Gradual increase in spectral band trends noted. Also noted was a high frequency vibration in the region of 5 kHz with side bands spaced at 2X LF, confirming that the Motor is running on a VSD and suspected fluting as a secondary effect.

The NDE bearing was cleaned and opened for inspection. The bearing outer race show clear signs of damage due to electrical fluting. The NDE bearing defect identified by Condition Monitoring was a result of electrical discharge through the NDE bearing. The erosion of the raceway resulted in contamination of the grease. Continued operation with this condition would have resulted in premature failure.

Initially it was recommended to ensure adequate bearing lubrication; however, no improvement was noted and as the defect progressed it was recommended to replace the Motor. The motor was then sent off site for inspection and repair.

Specific attention should be paid on drives that are equipped with Variable Speed Drives (VSD's), this includes Motor shaft grounding brushes that should be in place to discharge electrical currents to prevent secondary damage on motor bearings.
