# PRÜFTECHNIK *success story*

> Application **Cardan Shaft Alignment**

## Mine saves two workdays during time-critical shutdown

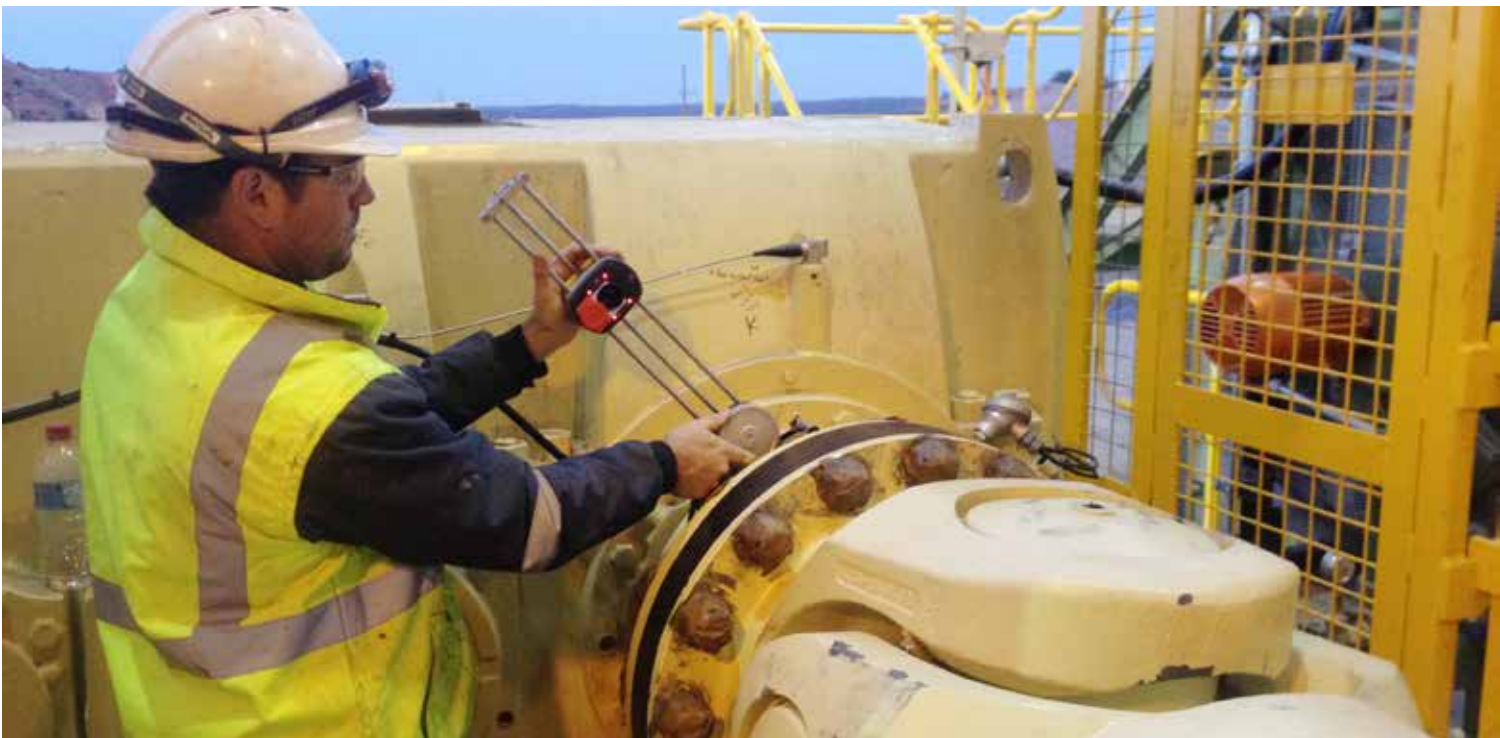
The laser was set up at the stationary end using a non-rotating arm bracket. At the moveable machine end of the shaft, a rotating arm bracket was used to mount the sensor. As the coupled shaft was rotated to each new measurement position, the rotating arm bracket was turned back at the base and the sensor moved along the posts to intersect the laser beam and take the necessary readings. The procedure was repeated at several shaft angular positions to capture the alignment condition, after which the required machine adjustments were made and checked.
