Company: AGL Loy Yang
 Location: Latrobe Valley, Victoria, Australia
 Service Provider: Optical Motion Technologies

Problem

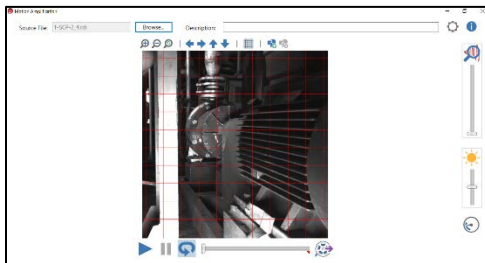
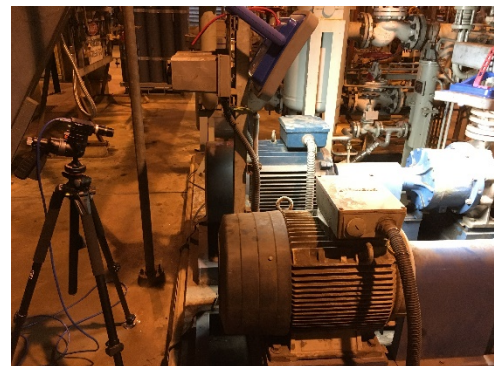
There are two (duty and stand-by) Stator Coolant Pumps (SCP) critical to the operation of each 500+ megawatt turbo generator at the Loy Yang Power Station. One of the two SCPs for Unit 1 turbo generator has had a long history, more than 10 years, of high lateral vibration, sometimes reaching 20 mm/sec RMS. There have been many attempts to remedy the problem at an estimated material cost of AU\$160k. This does not take into account the estimated labor cost of 500+ man hours and loss of power generation revenue. Some of the attempts to remedy the problem include: laser alignment, base frame spot welds, bracing of pipework, fitment of flexible bellows to the pump suction and discharge pipework, pump replacement x2, motor replacement, coupling replacement, etc...

Optical Motion Technologies (OMT) were contracted to apply RDI's Motion Amplification™ (MA) technology to solving the long running problem on 1-SCP-2. From arriving at the location of the SCPs in the power station, setting up the video camera acquisition system and then collecting nine MA videos took less than one hour. This hour included the time to analyze the results all of which was done in the field. The process involved taking wide angle 'whole of machine' videos, analyzing them in the field and then honing in with zoomed videos on the root cause of the problem. It was clear from the MA videos that the problem was a soft foot condition between the pump base frame and skid base plate. In fact, there was a twisting operational deflection shape of the pump base frame. During a scheduled outage, a series of fillet welds were made across the suction end the pump base frame to the skid base plate. When the pump was returned to duty service the high lateral motion and vibration had been reduced by more than 70% and was now less than 5 mm/sec RMS. The solution to this problem was achieved through the application of RDI's Motion Amplification™ technology for a fraction of the time and cost already incurred.

- Captured Motion Amplification™ (MA) videos and diagnosed the fault in the field within 1 hour
- Visualization of the root cause (structural fault) of the high vibration that has been undiagnosed for more than 10 years
- Simple and inexpensive remediation work during a scheduled outage reduced the high vibration by more than 70%
- The pump was returned to duty service rather than stand-by
- Solution implemented at a fraction (1%) of the cost of previous attempted
