# Over US\$48M value realised from Online Vibration Monitoring on a Colliery

Site: Colliery Machine: VSD Drive motor on Incline Conveyor Rating: 750Kw Problem Category: Bearing Defect caused by Electrical Fluting

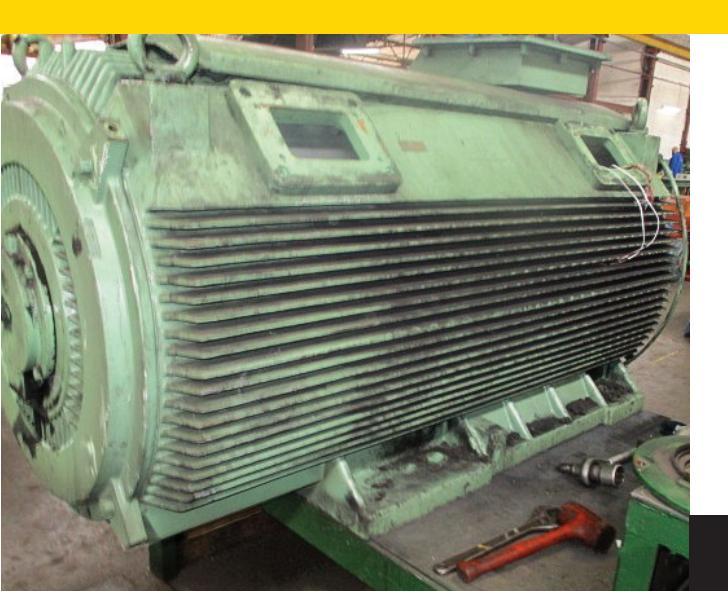
Alarm due to high vibration was observed on the NDE Motor Bearing. Harmonics of Outer Race Defect frequency at 177,6 Hz with side bands spaced at FTF (cage frequency) 10,67 Hz evident in the demodulation and acceleration spectral data comparisons. Gradual increase in spectral band trends noted. Also noted was a high frequency vibration in the region of 5 kHz with side bands spaced at 2X LF, confirming that the Motor is running on a VSD and suspected fluting as a secondary effect.

Notification was created and raised while it was still in initial stage and at low priority. As the defect progressed, the relevant Foreman was notified and the status was changed to high priority.

Initially it was recommended to ensure adequate bearing lubrication; however, no improvement was noted and as the defect progressed it was recommended to replace the Motor. The motor was then sent off site for inspection and repair.
