PRUFTECHNIK Service Center

Reducing Cardan Errors for Low-Vibration Operation of Coupled Machines

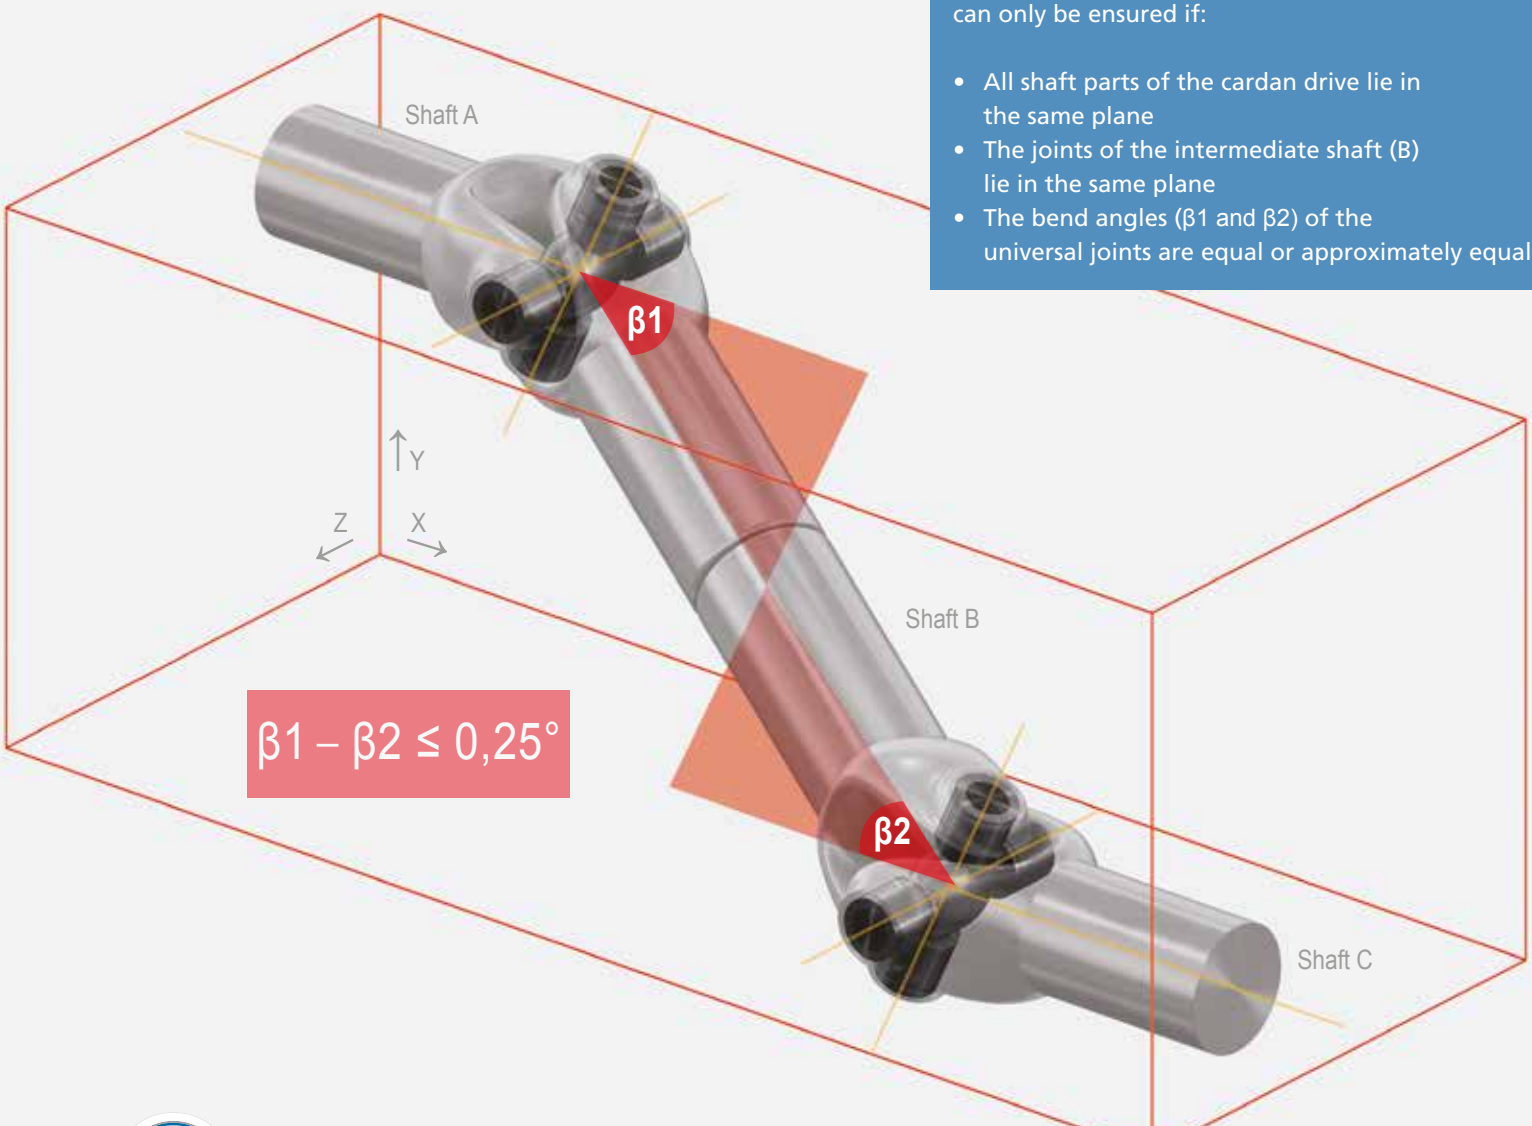
Synchronous run of both shaft parts (A and C) can only be ensured if:

- All shaft parts of the cardan drive lie in the same plane
- The joints of the intermediate shaft (B) lie in the same plane
- The bend angles (β_1 and β_2) of the universal joints are equal or approximately equal

The 3 shafts and the 2 joints of the cardan must lie in the same plane. The bend angles β_1 and β_2 of the universal joints 1 and 2 must be approximately equal.

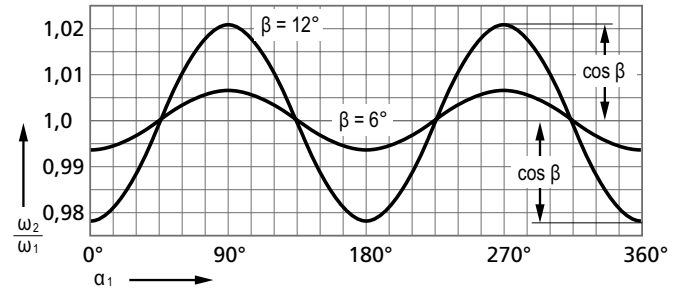
During one revolution of shaft A, the acceleration and deceleration maximum is passed twice in shaft B. This Cardan error means a sinusoidal variation in the angular speed that can be calculated using this function for every rotational position.

$$\omega_2 = \frac{\cos \beta}{1 - \sin^2 \alpha_1 \cdot \sin^2 \beta} \cdot \omega_1 \quad \left[\frac{1}{s} \right]$$

Here, α_1 is the angle of rotation of drive shaft 1.
 β is the bend angle of the joint.

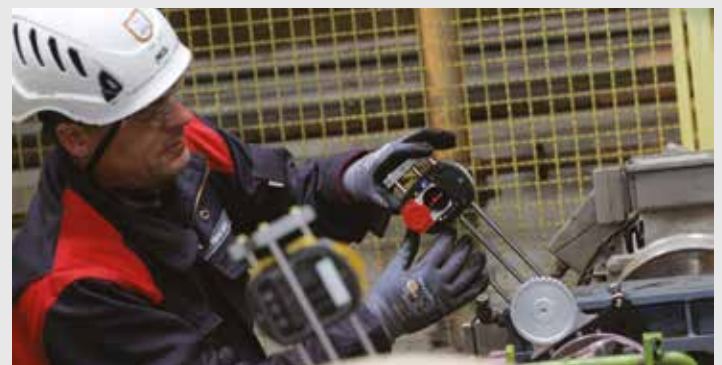
Laser-optical alignment of an installed cardan shaft

However, achieving perfect compensation is difficult in reality and requires competent laser-optical alignment of cardan shafts in the removed as well as installed state.
